Abandoned Cold Storage Warehouse Multi-Firefighter Fatality Fire

Worcester, Massachusetts

December 1999

This is Report 134 of the Major Fires Investigation Project conducted by Varley-Campbell and Associates, Inc./TriData Corporation under contract EME-97-CO-0506 to the United States Fire Administration, Federal Emergency Management Agency.

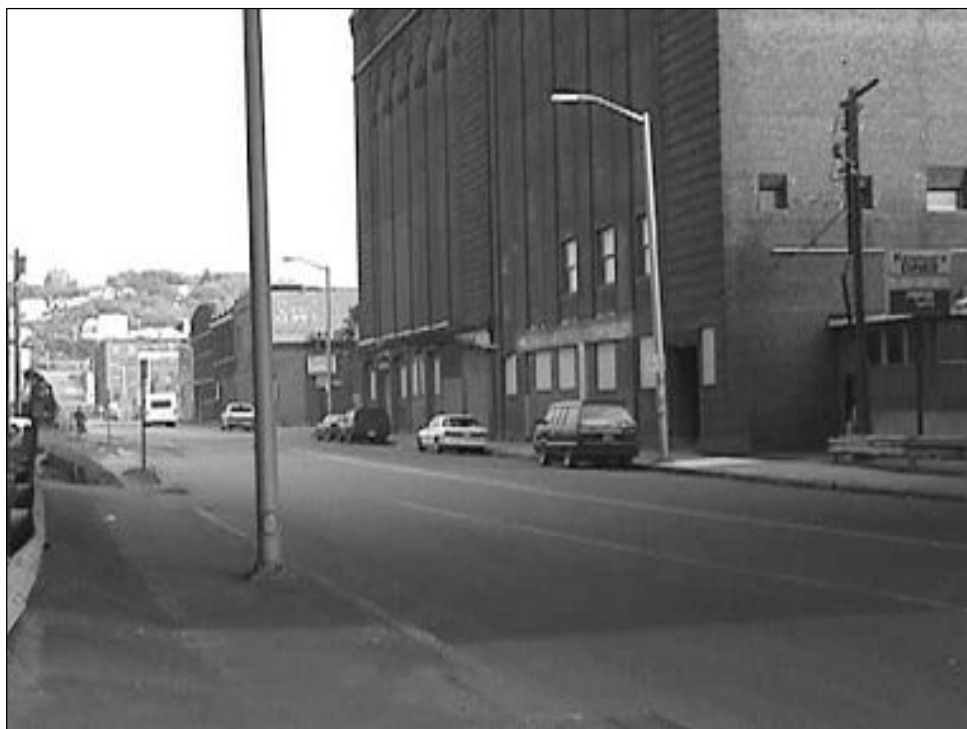
Warehouse D/A Corner

Exterior units reported a six foot crack in the brick wall at the top of the D/A corner, and the warehouse's structural integrity was in question. Firefighters recalled

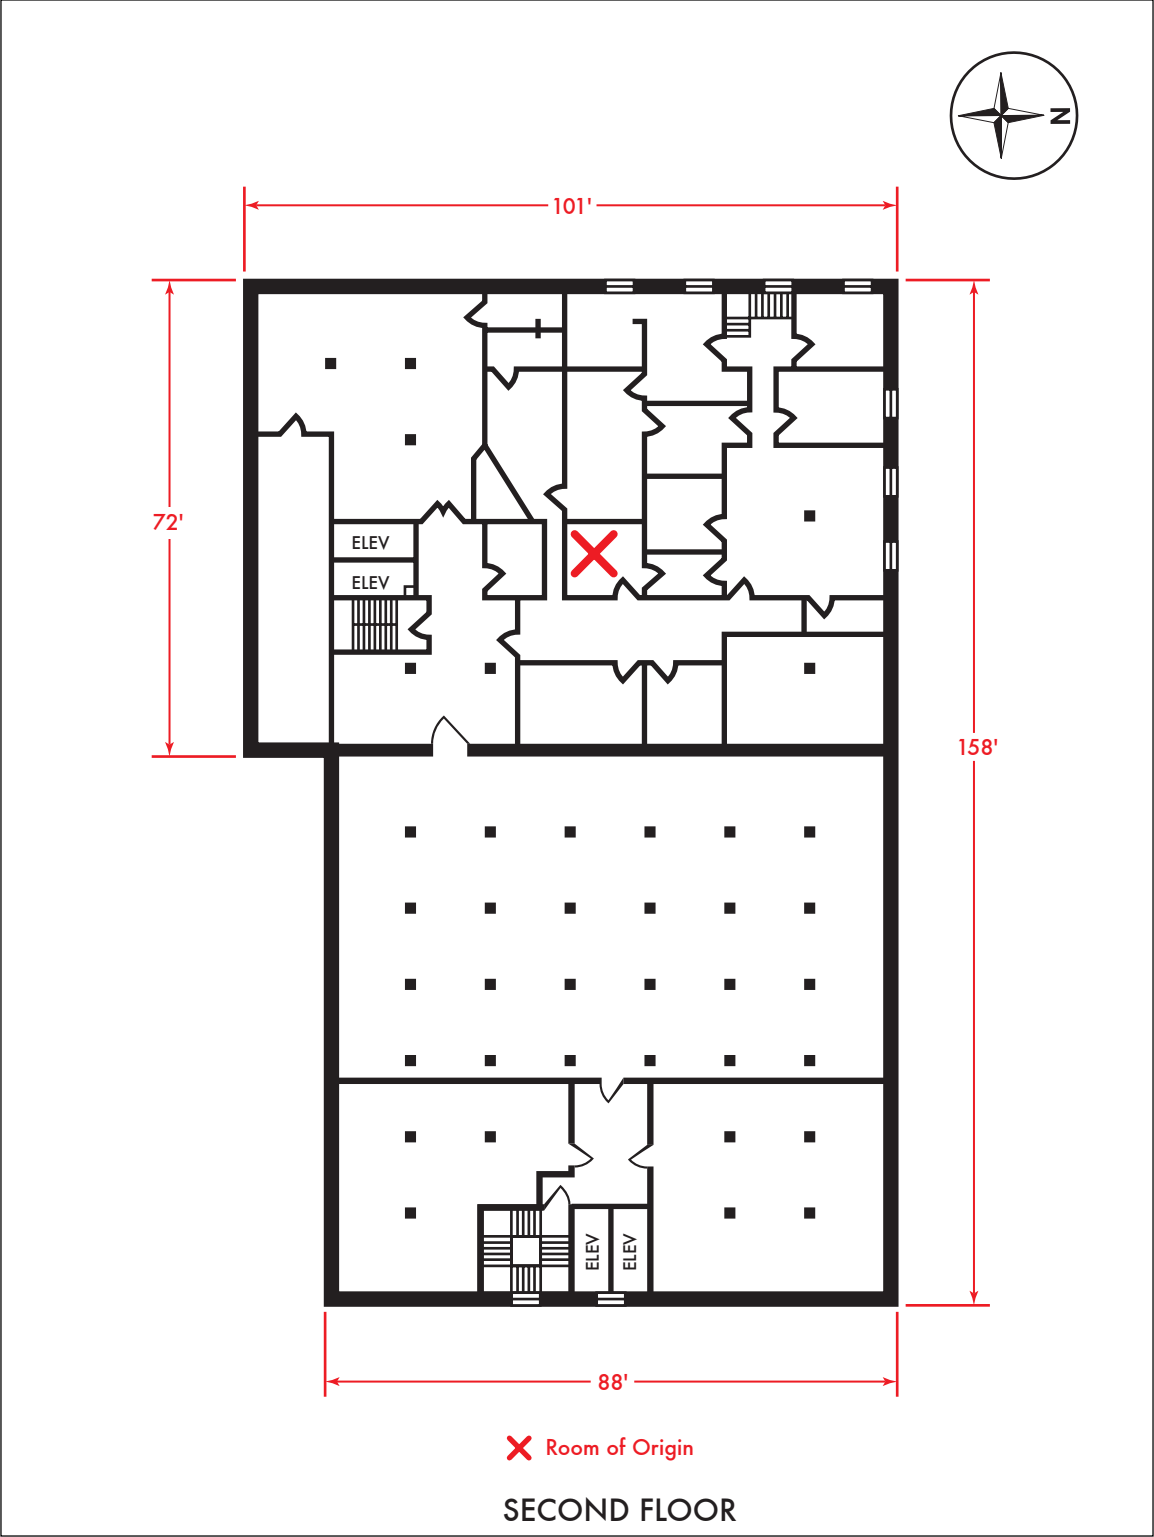
Room of Origin

The area of origin was discovered to be in an office on the second floor of B-building. (See Appendix E) The cause was determined to be an accidentally overturned candle used to light the room. This happened during a fight between a homeless man who resided in the space and his homeless girlfriend who had recently moved out. She returned to the warehouse in the late afternoon of December 3rd to pick up some belongings and encountered her former boyfriend. A brief shoving match caused the lit candle to fall off a milk crate and into a pile of clothing. Attempts to beat out the flames were unsuccessful, and the fire fed on the combustibles strewn around the room.

The initial report from Ladder 1 on the second floor describes a "room full of fire" in B-building beyond the door in the party wall. This location is some 30 feet from the room or origin, so a one room fire had enough time to engulf the entire floor. A sustained flow of 1000 GPM for 20 minutes had virtually no effect on the fire, and conditions deteriorated around attack crews. (See Appendix E - Room of Origin.)

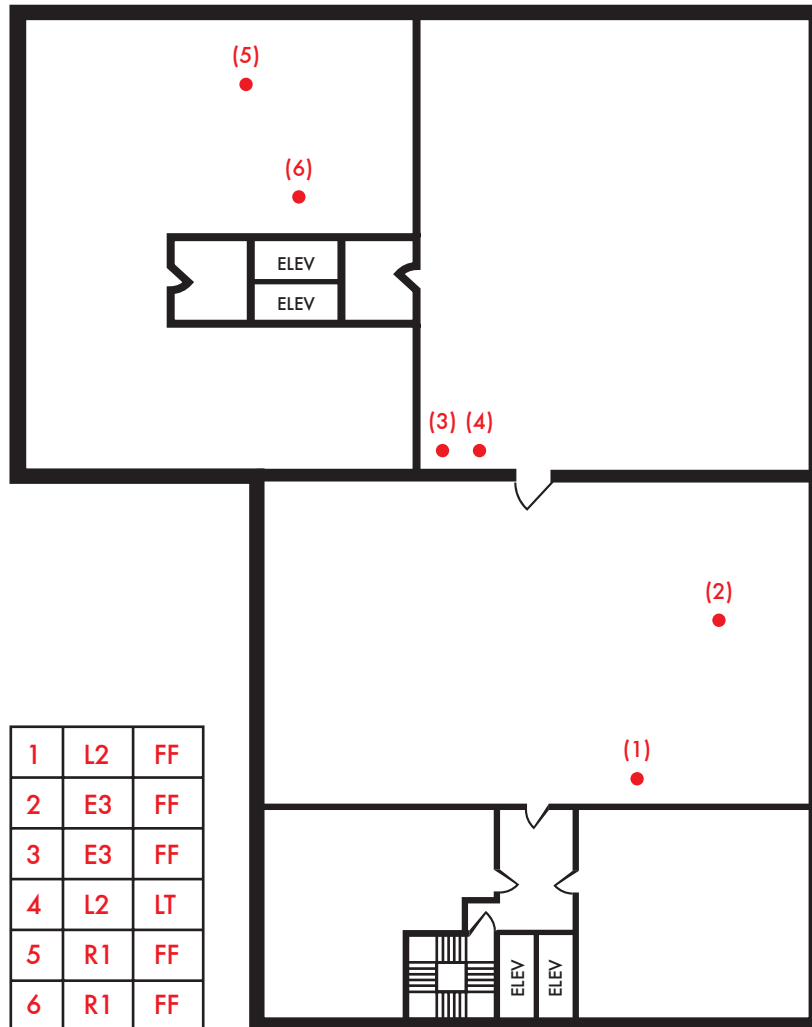
Fifth Floor Fatality Locations

1	L2	FF
2	E3	FF
3	E3	FF
4	L2	LT
5	R1	FF
6	R1	FF

Note: The marked locations are where the remains were recovered on the 2nd Floor. Their actual locations on the 5th Floor are unknown.
